**PHASE I ENVIRONMENTAL SITE ASSESSMENT
APPROXIMATELY 301 ACRES OF LAND
LOCATED NEAR DURANT, BRYAN COUNTY, OKLAHOMA**

**TERRACON PROJECT NO. 03067744
AUGUST 8, 2006**

**Durant Industrial Authority
215 N. 4th Avenue
Durant, Oklahoma 74701**

Terracon
**5301 BEVERLY DRIVE
OKLAHOMA CITY, OKLAHOMA**

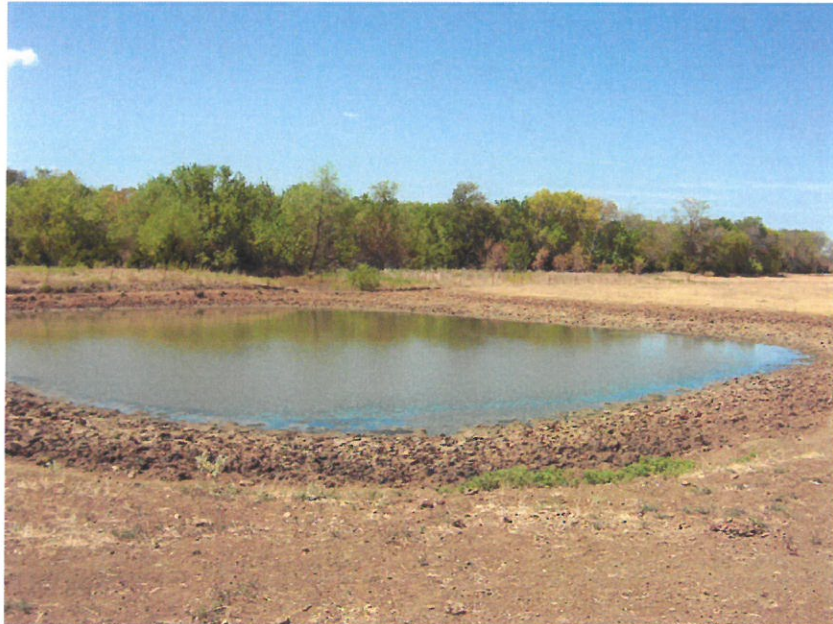
Photograph 12 View of pond located on Tract 2 of Area 1.

Several small surface ponds were observed on the Site property, in use for livestock. No chemical or hazardous waste storage was observed in the vicinity of these ponds and they do not appear to present a REC to the Site property.

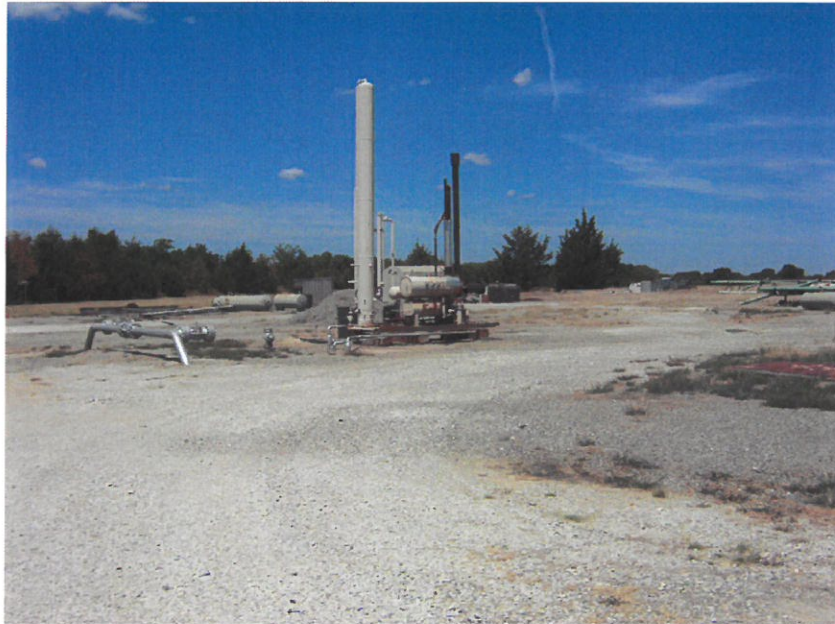
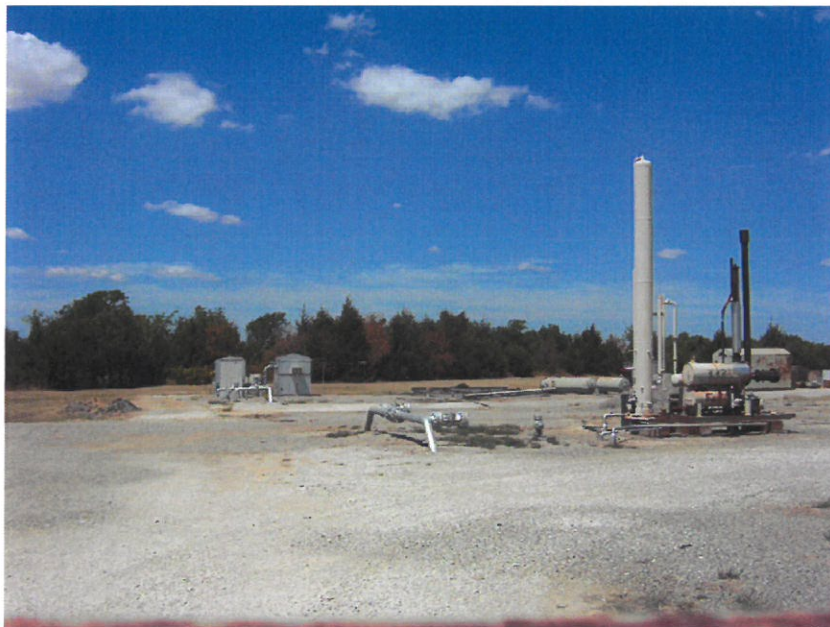
Photographs 19 & 20 Views of oilfield gas compressor and meter station, located near the southeast corner of Tract 3 of Area 2. This production site encompasses approximately 2 acres, and is not part of the Site property.

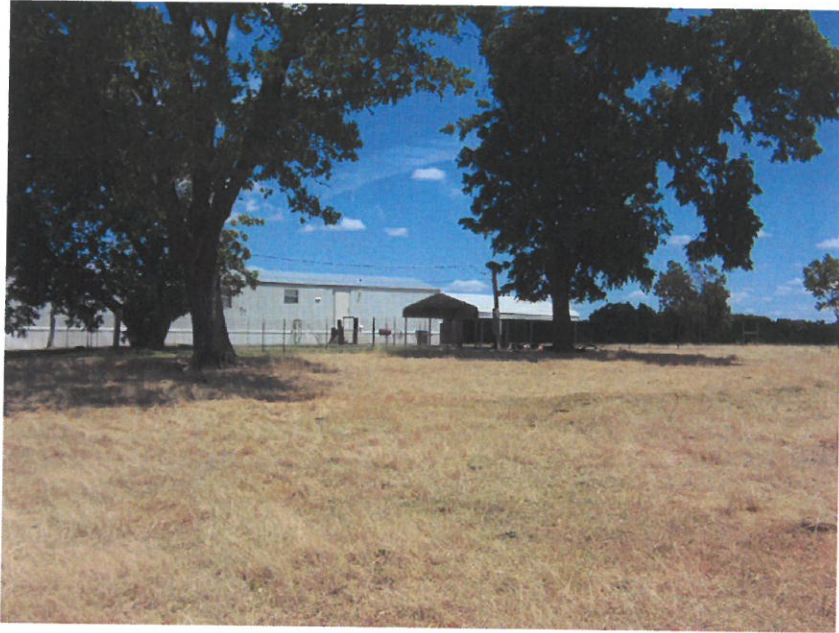
Photograph 27 View of south side of above noted trailer home located on Tract 4.

According to the Site owner, a septic tank, of unknown capacity, and associated equipment, is located on the southern side of the mobile home which is located on Tract 4 of Area 2 of the Site. Associated lateral lines were reported to run to the south. No evidence of seepage or odors indicating a leak were observed at the time of the Site reconnaissance, and this septic tank system does not appear to present a REC to the Site property at the present time.

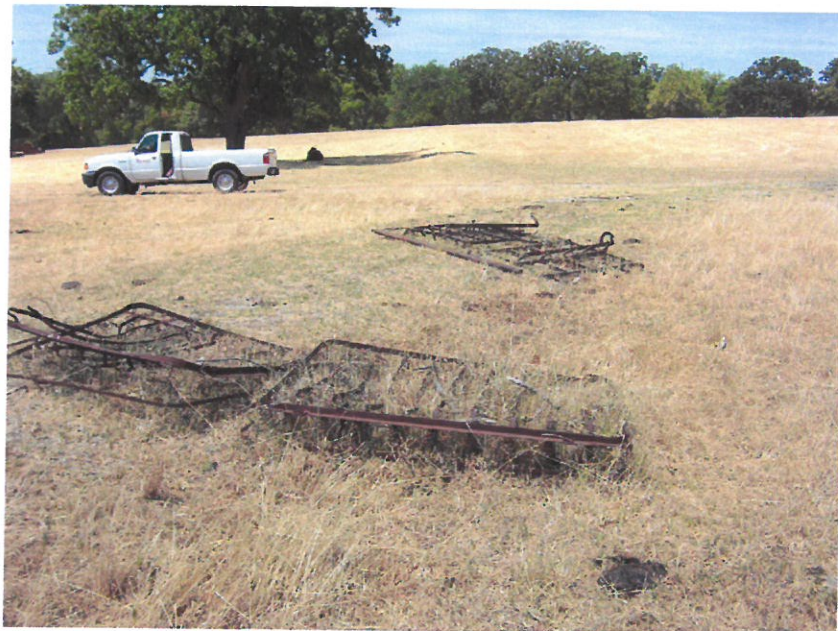
Photograph 34 View of household refuse located on Tract 4.

As shown in Photographs provided in Appendix E of this report, minor amounts of debris were observed on the Site during the site reconnaissance, primarily in a drainage tributary located on Tract 4 of Area 2. This debris appeared to consist primarily of household refuse, including a discarded refrigerator, auto batteries, a bedframe and boxsprings, etc. This debris did not appear to be of a hazardous nature and thus does not appear to constitute a REC at this time. However, it is recommended that this debris be disposed of prior to any future construction or development activities.

However, as discussed in detail in Section 5.2.1 of this report, it is recommended that the minor amounts of debris and household refuse observed on Tract 4 of Area 2 be disposed. In addition, the Site owner advised Terracon that a water supply well is located on the eastern portion of Tract 1. If this well can be located and is not going to be put into future use, it should be plugged according to applicable OWRB rules and regulations.

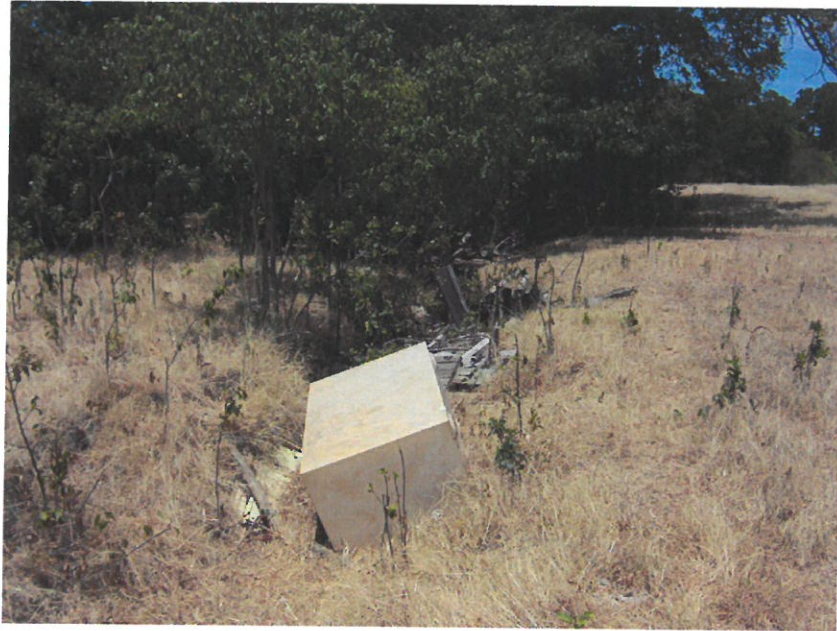
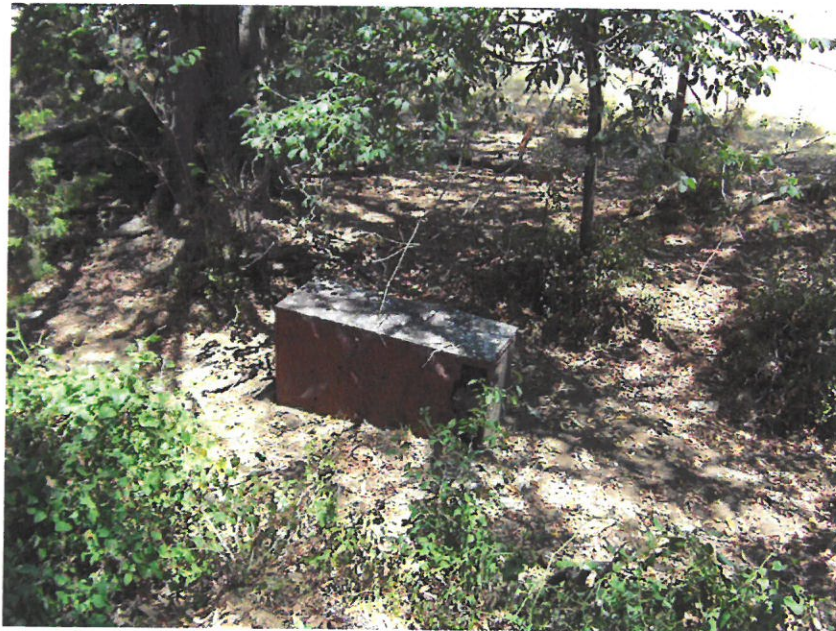
Photographs 37 & 38 Views of household refuse dumped in small creek tributary, located near central portion of Tract 4 of Area 2.
